ROWLEY'S WAREHOUSE AND MANSION Conservation Management Plan

FINAL VERSION FOR ADOPTION: MARCH 2025

PREPARED FOR SHROPSHIRE COUNCIL BY TDR HERITAGE LTD

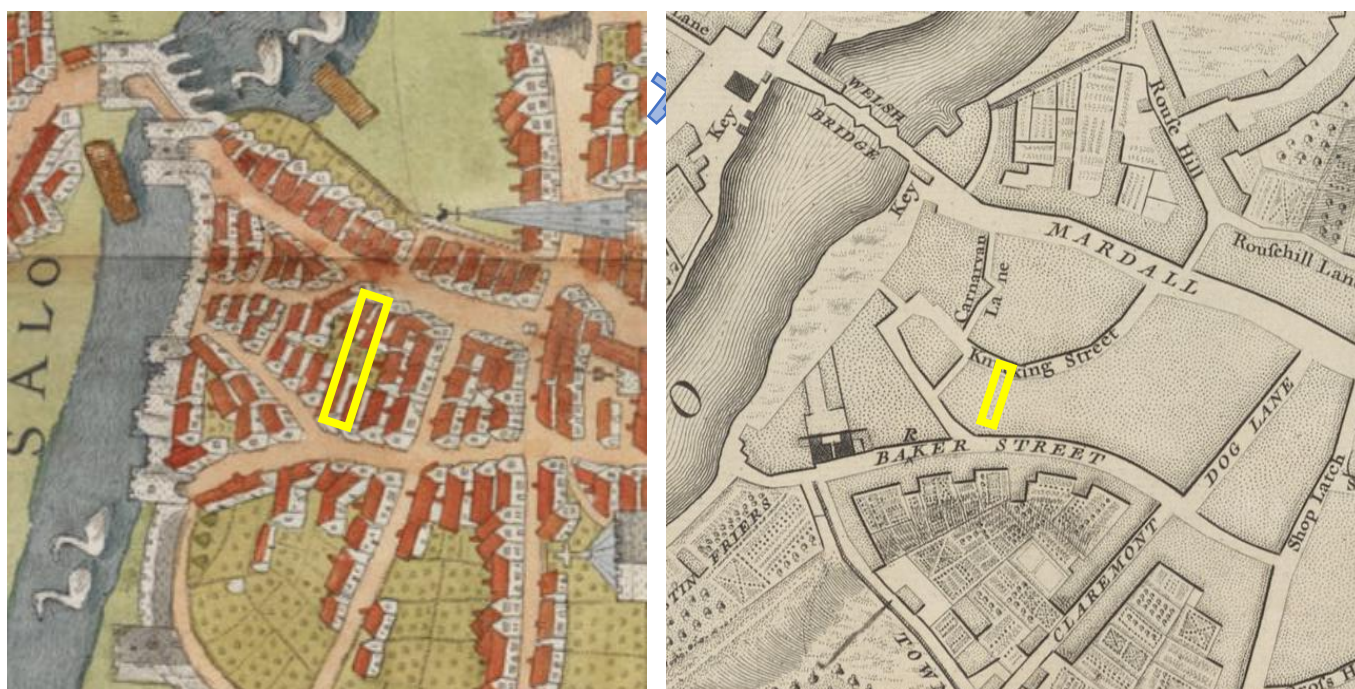
Figure 2: Excerpts from Burghley's Map of Shrewsbury of 1575 (left) SA 680/1 and Copy of Rocque's Map of Shrewsbury of 1746 printed in 1860 by John Davies (right) SA TP/12 showing the continuation of the early street pattern through the Post-Medieval period and the approximate location of Rowley's House and Mansion.

By the later medieval period, the area comprised a mix of buildings from high-status stone properties, such as Cole Hall (now demolished), to humbler dwellings alongside commercial and industrial buildings, particularly tanneries. An aerial view of the town of c.1575, known as the 'Burghley Map' of Shrewsbury (figure 2), shows the location of Rowley's Warehouse and Mansion just prior to its construction. This shows a relatively densely developed area, formed by a number of domestic and unheated (potentially industrial) buildings with their gables generally facing onto Hill's Lane and Barker Street, with some of the properties having small, enclosed plots of land behind them. Later maps show that this late medieval street system became 'fossilised' within new development and building work from the 17th century onwards and was maintained until the extensive slum clearances and road widening that was carried out in the area in the 1930s.

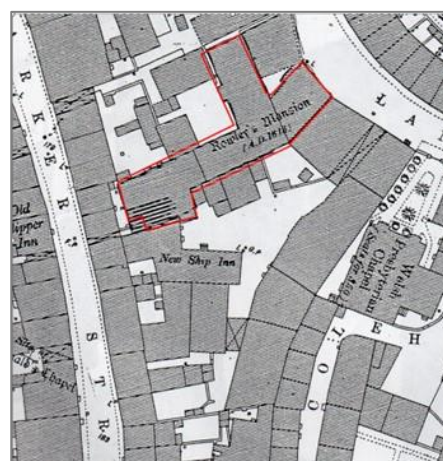
Figure 3: Rowley's Warehouse and Mansion shown at the end of the 19th century (Ordnance Survey, 1882. Reproduced with permission of National Library for Scotland.)

The new building is likely to have replaced earlier structures in this densely developed area and was surrounded by other buildings, including a row along the old line of Barker Street (which was altered in the 1930s) that would have masked Rowley's Warehouse from view (see figure 3).

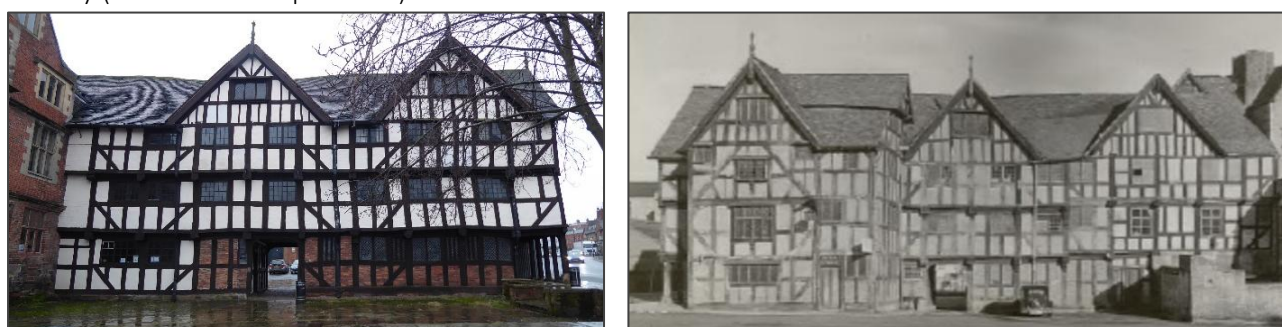
Figure 5: Modern images of Rowley's Warehouse west elevation (left) and east elevation (right). Part of the original east elevation is concealed behind the later additions of the east wing and stair tower (see below). (Images: TDR Heritage 2023 & JT Smith 1953).

The square panelled timber frame was constructed with wattle and daub infill and was designed to have great strength, with the first and second floors being jettied to maximise the available internal space. Internally the building was largely open on each floor with – initially- only a single partition which subdivided the space into a very long and a long room in the same location on each level. To achieve this openness, the weight of each floor was carried by six substantial main beams with a very large bridging beam halfway between each (figure 4). The building was well ventilated and, even in its earliest phase, well lit with numerous unglazed window openings to the long east and west elevations, all of which indicate that it was a commercial or industrial building designed to provide storage for wool or brewing materials rather than for the storage of grain. Although there are no datable features for this phase of the building, Morriss noted it has similarities with a woolstore that formed part of the Fellmongers complex in Frankwell, which is known to be of the late 16th century (Morriss & Stamper 1995).

Not long after its construction, the building underwent some key alterations. Firstly, gabled dormers were added to the east and west sides of the main roof, perhaps to increase the storage space and improve light in the attic which, with two metres of head height, seems to have been designed to be used (figure 5).

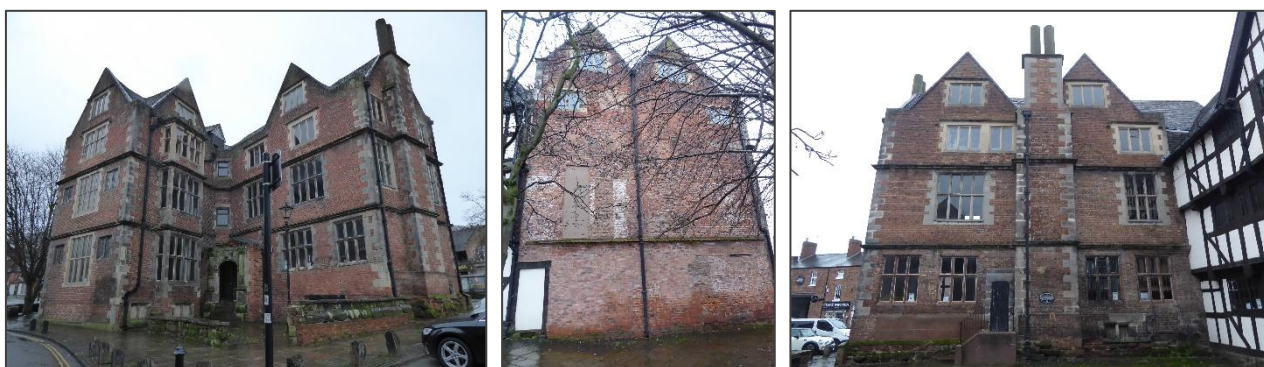
Figure 9: The brick Jacobean style 'Rowley's Mansion' of a north and west wing was added onto the warehouse in c.1616. Left: the principal elevation is formed by the two wings, designed to be seen on the approach from Hills Lane; Centre: the east elevation of the north wing had few features and was built up against another timber framed structure that was demolished in 1930s; Right: west wing, south elevation (Images TDR Heritage 2023).

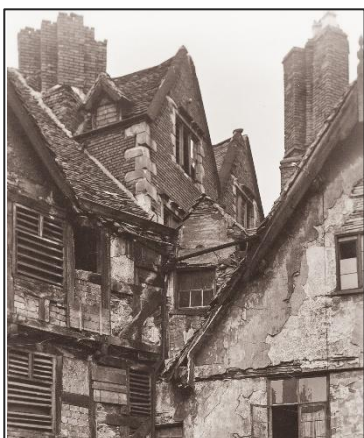
Figure 10: Photograph of the early C20 showing the east elevation of the North Wing and the abutting timber-framed building. The image also shows the eastern roof gablet which is no longer visible (SA PH/S/13/B/1/108) (Judges Ltd).

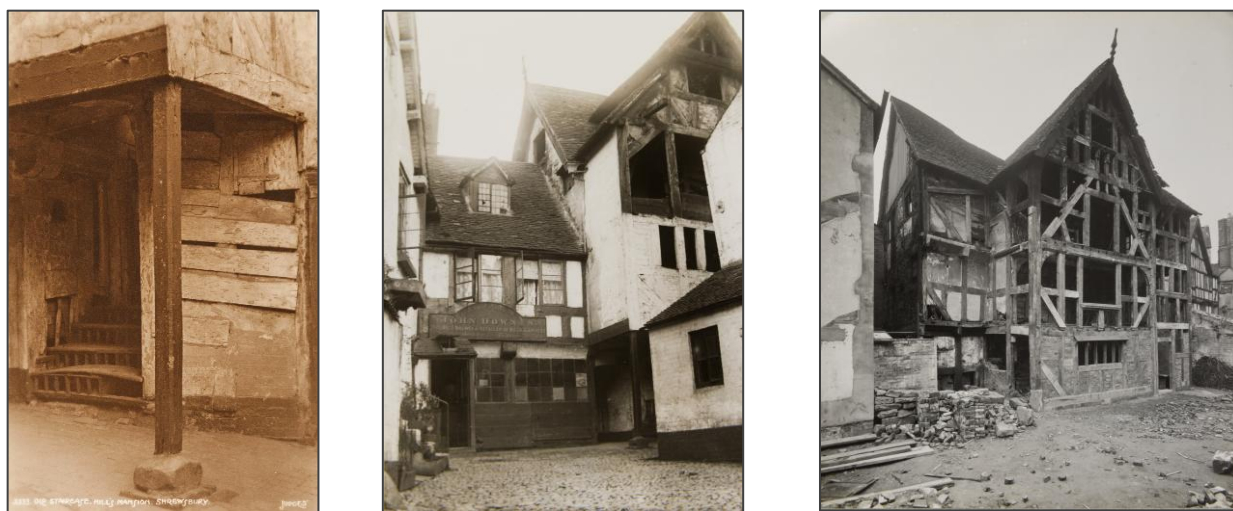
Figure 12: Left and middle: The stair tower was openly accessed from the Ship Inn Yard by at least the late C19. This was altered in 1930 when the Ship Inn was demolished and new timber and brick panels and a door were introduced to enclose the access. This level of alteration highlights the degree of uncertainty which must be placed on the modern appearance of the ground floor of the east wing (Images: SA PH/S/13/B/1/110; SA 6001/3191/18; SA 6001/3191/28).

The staircase, which is believed to have been original, and which was apparently dated 1641, was removed and sent to the USA in the early 20th century prior to the 1930s restoration work. An early 20th century photograph of the building prior to its restoration shows open access from the yard to the stair with a post on a footpad forming the corner of the stair tower (figure 12). This open arrangement was altered in the 1930s restoration when the two storey section of the east wing was demolished, with the new work enclosing the bottom of the frame with brick panels with a new door (see figure 11). The restoration is reported to have recreated a 'close copy' of the original, including the use of spindles in the bottom steps to light the cellar, using an early photograph [although no copy of any image other than that shown in fig.10 has been located] and material from other historic buildings which were being demolished in the overall redevelopment scheme (Ward 1938).

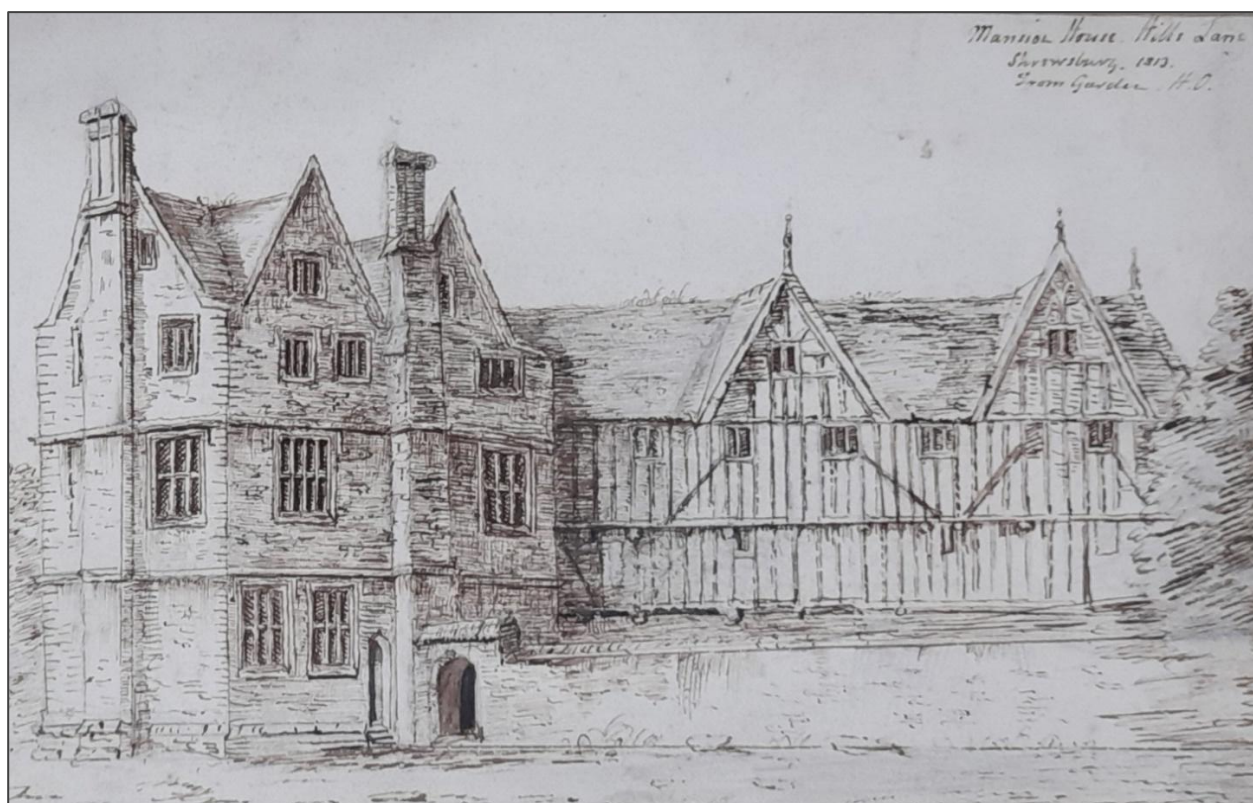
Figure 14: Illustration of Mansion House Hills Lane Shrewsbury from Garden, 1813 by H.O [Hugh Owen] (SA 6001/200/66).

Although slightly later in date, the Mansion was the subject of paintings from the early 19th century which provide an insight into its appearance in the late 18th and 19th century. The earliest drawing, entitled 'Mansion House, Hill's Lane Shrewsbury. From Garden' is of 1813 (figure 14) and shows the west wing of the Mansion and the west elevation of the timber framed warehouse enclosed by a coped, garden-style wall, probably of brick, running south from the central chimney stack of the west wing of Rowley's Mansion. Directly adjacent to the stack is an arched gateway through the wall providing access to the yard. The wall appears to be aligned with the property boundaries of the time which ran at right-angles to Barker Street.

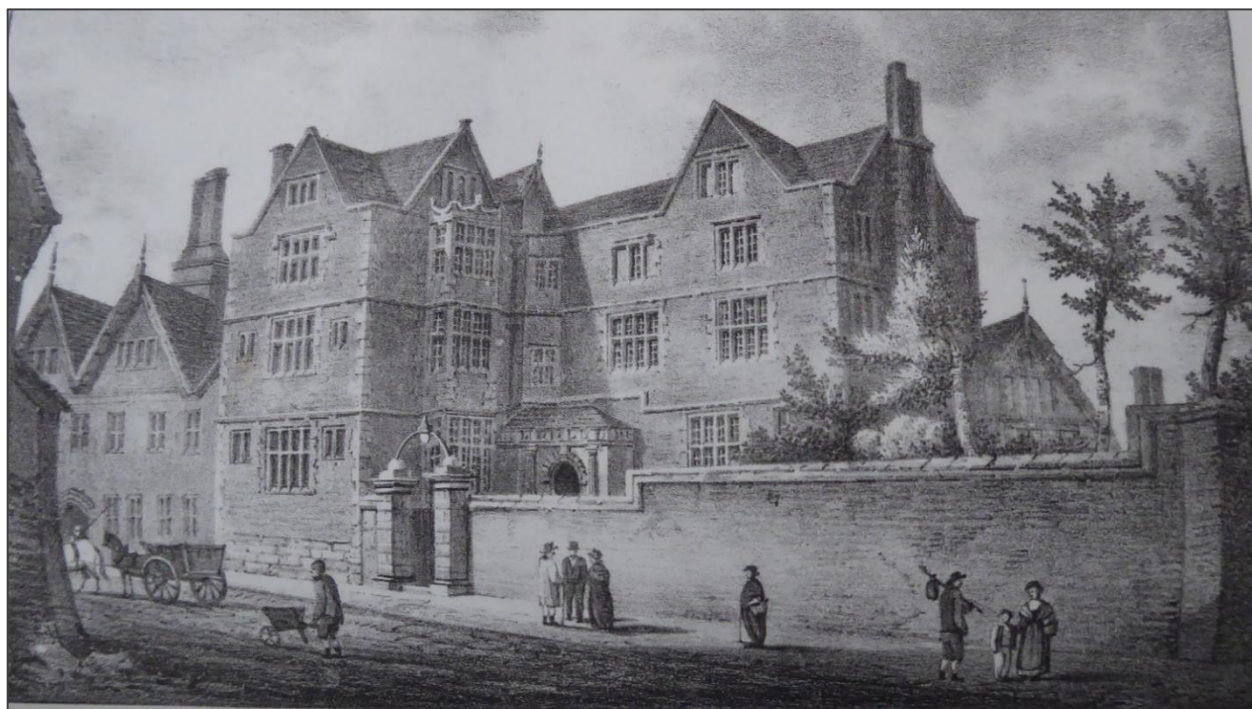
An almost contemporary view of the Mansion from the north west of c.1820 (figure 15) shows the area between the two brick wings enclosed behind a coped brick wall, probably of 18th century date. This ran along

Hill's Lane with a small but impressive entrance stone gateway providing pedestrian access to the porched entrance into the Mansion. Above the gateway was a narrow metal arch carrying a lantern.

Figure 15: Rowley's Mansion, Hill's Lane as illustrated in Owen & Blakeway 1825, p409. (SA PH/S/13/H/5/1)

A timber and weatherboarded structure had been constructed immediately west of the western gable of the Mansion (shown on figure 15) and may relate to the use of the Mansion as a bark warehouse. Despite these alterations, the photographs also show that a number of architectural features had survived, including the moulded brick windows on the ground floor of the south elevation of the Mansion's west wing.

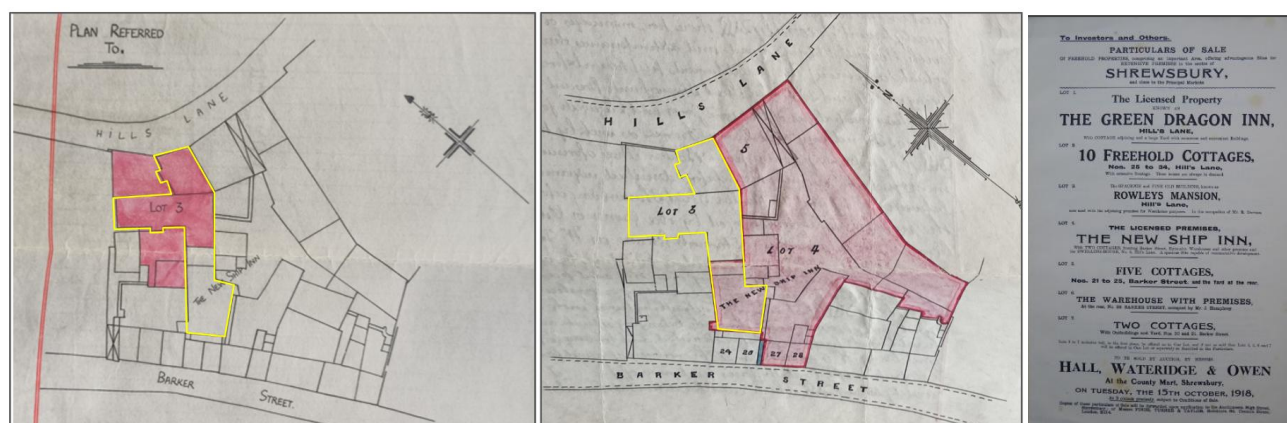
Figure 17: Plans of Lots 3, 4 and 5 which accompanied the conveyances of land sold between Barker Street and Hills Lane in 1919, with the modern extent of the Rowley's Warehouse and Mansion buildings marked in yellow (Shropshire Council). Right: Cover of auction particulars from the sale of October 1918 (SA: SC/1/30).

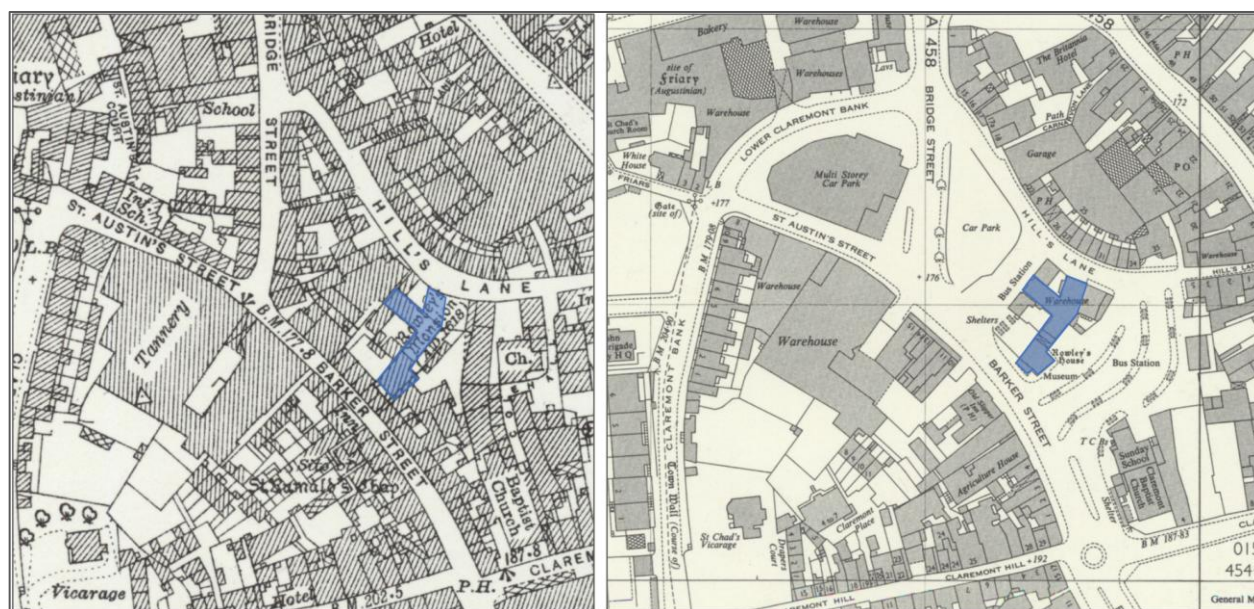
Figure 18: Ordnance Survey maps showing the extent of change carried out by the Corporation to create the 'Inner Loop' road in the 1930s, showing Rowley's Warehouse and Mansion (in blue) and their environs in 1925 and 1963. Reproduced with permission of National Library for Scotland.

In 1929, an Inner Loop Road and central car park and bus station scheme was formally approved by the Corporation which resulted in massive and wide-reaching changes in the vicinity of Rowley's Warehouse and Mansion. It included improving access to Welsh Bridge by widening and straightening Barker Street as well as the creation of a central car park and bus station. The scheme involved the 'sacrifice' of numerous 'picturesque but insanitary' properties in the adjacent streets and alleyways, including the properties forming the east side of Barker Street, including the New Ship Inn, part of which is now fossilised in the end gable of Rowley's Warehouse (see above) (Champion & Thacker 2014; Ward 1938, 1) (figure 18).

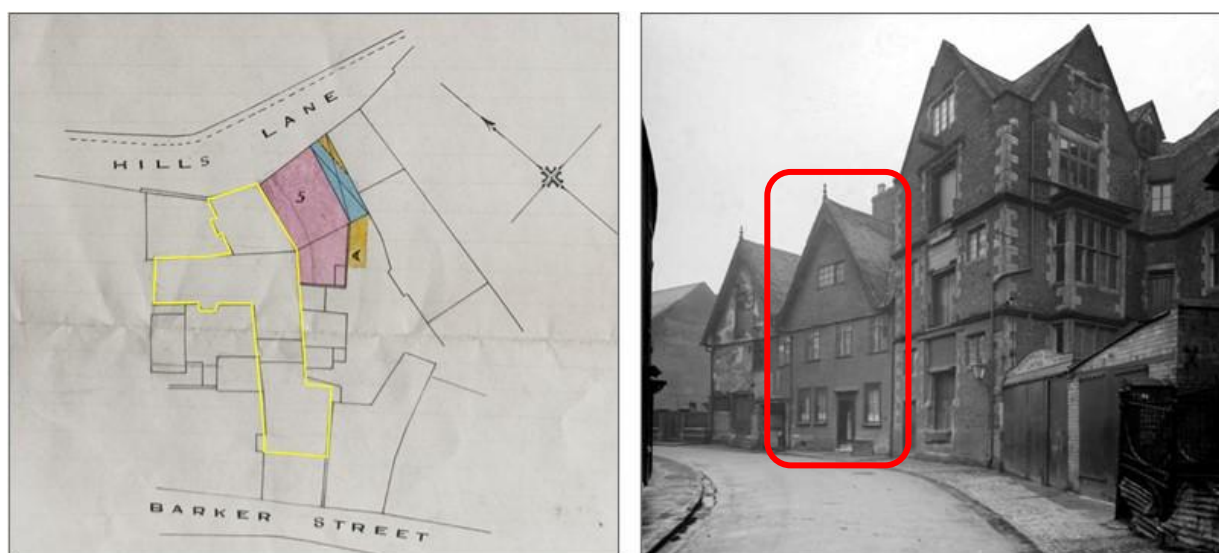
Figure 19: Lot 5 shown in a conveyance of 1928, the modern extent of Rowley's Warehouse and Mansion buildings is marked in yellow (Shropshire Council, Conveyance dated 5th March 1928). Right: Photograph of 5 Hills Lane probably c.1930, which was owned and occupied, along with the Mansion, by R A Downes (SA: PH/S/13/H/5/2.)

Presumably in an early response to the emerging scheme, Morris and Co sold 5 Hills Lane to R A Downes and Son Ltd in 1928, which enabled Downes to consolidate and expand the warehousing and stores they were already operating in the Mansion and the other properties they had purchased in 1919 (Shropshire Council, Conveyance dated 5th March 1928) (figure 19).

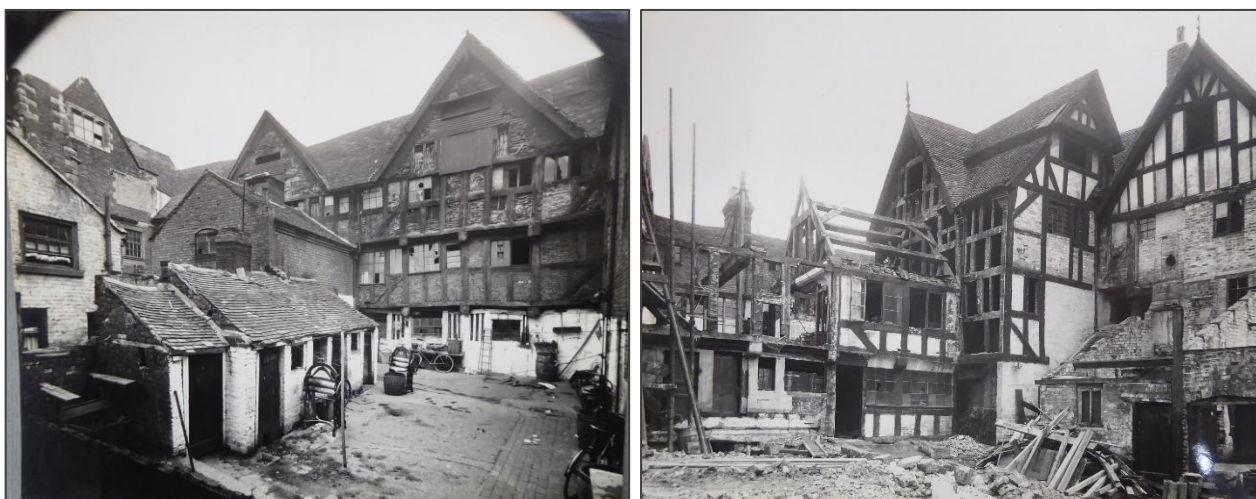
Figure 20: Left: Rowley's warehouse in the early C20th Left: West elevation in c. 1932 (SA: 6001/3191/20) and Right: East elevation in the early 1930s, following the start of demolition work in New Ship Inn Yard (SA: PH/S/13/B/1/23).

At the time of the restoration, Ward recorded that there was still an open stone walled basement beneath the whole of Rowley's Warehouse, which was accessed from the stair tower (the historic photograph in figure 12 showing that the descent into the cellar having been lit by spindles in the lower steps of the original stair). Oak sill beams sat on the stone basement walls but, as a result of the ground level on the west side of the building (described by Ward as the 'north side...overlooking the river') having become much higher than the internal floor with earth covering the sill beam, there had been considerable decay which had also resulted in some of the bottoms of the posts sitting on the sill to fail. Brick and stone had been used to try and pack these areas up and the timbers in the ground floor wall frame had mostly decayed or had been removed and replaced with rough brickwork (figure 20). These interventions had not only given the ground floor frame irregular levels, particularly on the western side, but also seem to have caused additional damage to the ends of some of the first floor projecting floor beams. These were being supported by the inserted brick walling and were suffering from cracking and rot in the very deep mortices that had been '*cut into the ends of these beams (for internal brackets and external frame) [which] had weakened them considerably where they should have been strong enough to support the superstructure*'. As a result, the restoration included the replacement of the sill beams and all decayed timber on ground floor whilst the defective ends of the first floor projecting beams were spliced or otherwise repaired, and brackets were added to give extra support.

At roof level, the roof structure itself was considered to be 'fairly sound' but the absence of 'proper rainwater goods' had caused some deterioration. Apart from the projecting floor beams, Ward noted that the beams to the first, second and third floors were sound and very few floor joists needed renewal. However, throughout the building the floorboards were 'either worn out or decayed' and the second floor was covered with 'paving bricks'. Ward replaced all the oak flooring with salvaged boards from demolished buildings and placed asbestos fireboards over the joists to 'resist fire and reflect light' (Ward 1938, 7). The basement below Rowley's Warehouse was also filled with brick rubbish and the floor over it was '*paved with old stone flags in Dutch courtyard fashion after precautions had been taken to prevent damp rising from the walls into the timbers*' (Ward 1938, 6).

Throughout the building, the windows had '*little or no glass, and few frames in the window openings*' (figure 20) and it seems likely that they were all replaced with new windows, glazed '*in all the leaded windows [with] old glass of good quality collected from other building or contributed by local residents. These include the bulls eyes. Sliding sashes on upper floors are glazed in the main with Georgian Crown glass*' (Ward 1938, 8).

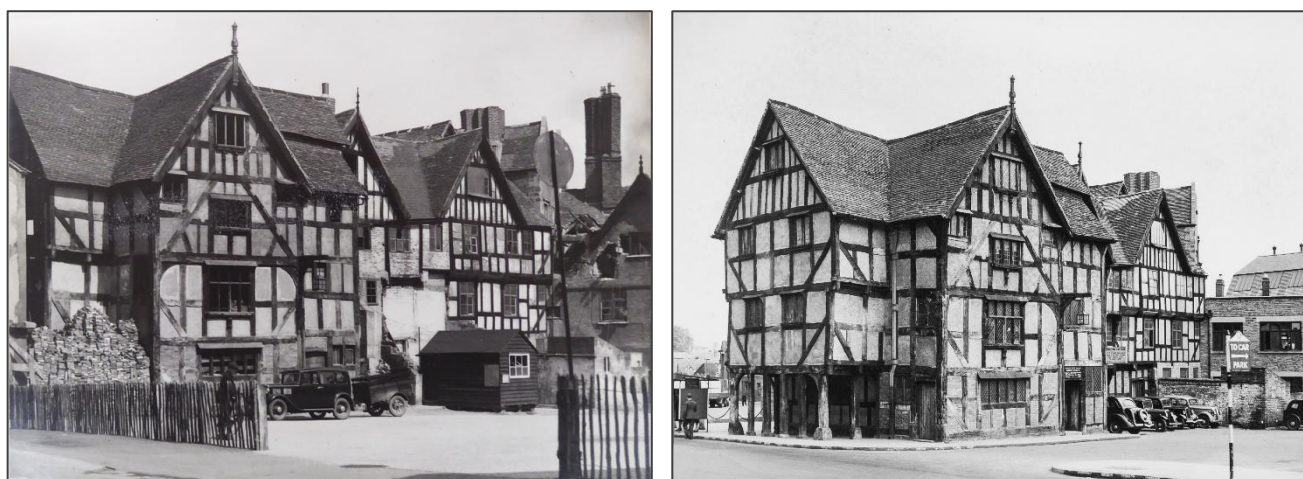
Figure 21: Left: Rowley's warehouse, May 1935 (SA: 6601/3191/29) and Right: a similar view in c.1950 (SA: PH/S/13/B/1/18).

The demolition and restoration work carried out in the Barker Street area was wide ranging but did not affect Rowley's Mansion which – along with the site of 5 Hills Lane and some land to its rear- remained in the occupation of R A Downes Ltd, as did the northern part of Rowley's warehouse. A photograph of the Site taken in 1935 shows that aspects of the restoration work were carried out in a relatively piecemeal fashion, starting with the Barker Street end and the (now foreshortened) east wing (figure 21).
